**FIRE AND GROUNDING OF THE TUGBOAT SCANDIA, O.N. D517785, AND
GROUNDING OF THE TANK BARGE NORTH CAPE, O.N. D591040, OFF POINT
JUDITH, RHODE ISLAND ON JANUARY 19, 1996, WITH MAJOR POLLUTION AND
NO PERSONAL INJURIES OR LOSS OF LIFE**

16732/MC96000914
27 January 1998

Subj: INVESTIGATION INTO THE CIRCUMSTANCES SURROUNDING THE FIRE
AND GROUNDING OF THE TUGBOAT SCANDIA, O.N. D517785, AND
GROUNDING OF THE TANK BARGE NORTH CAPE, O.N. D591040, OFF
POINT JUDITH, RHODE ISLAND, ON JANUARY 19, 1996, WITH
MAJOR POLLUTION AND NO PERSONNEL INJURIES OR LOSS OF LIFE

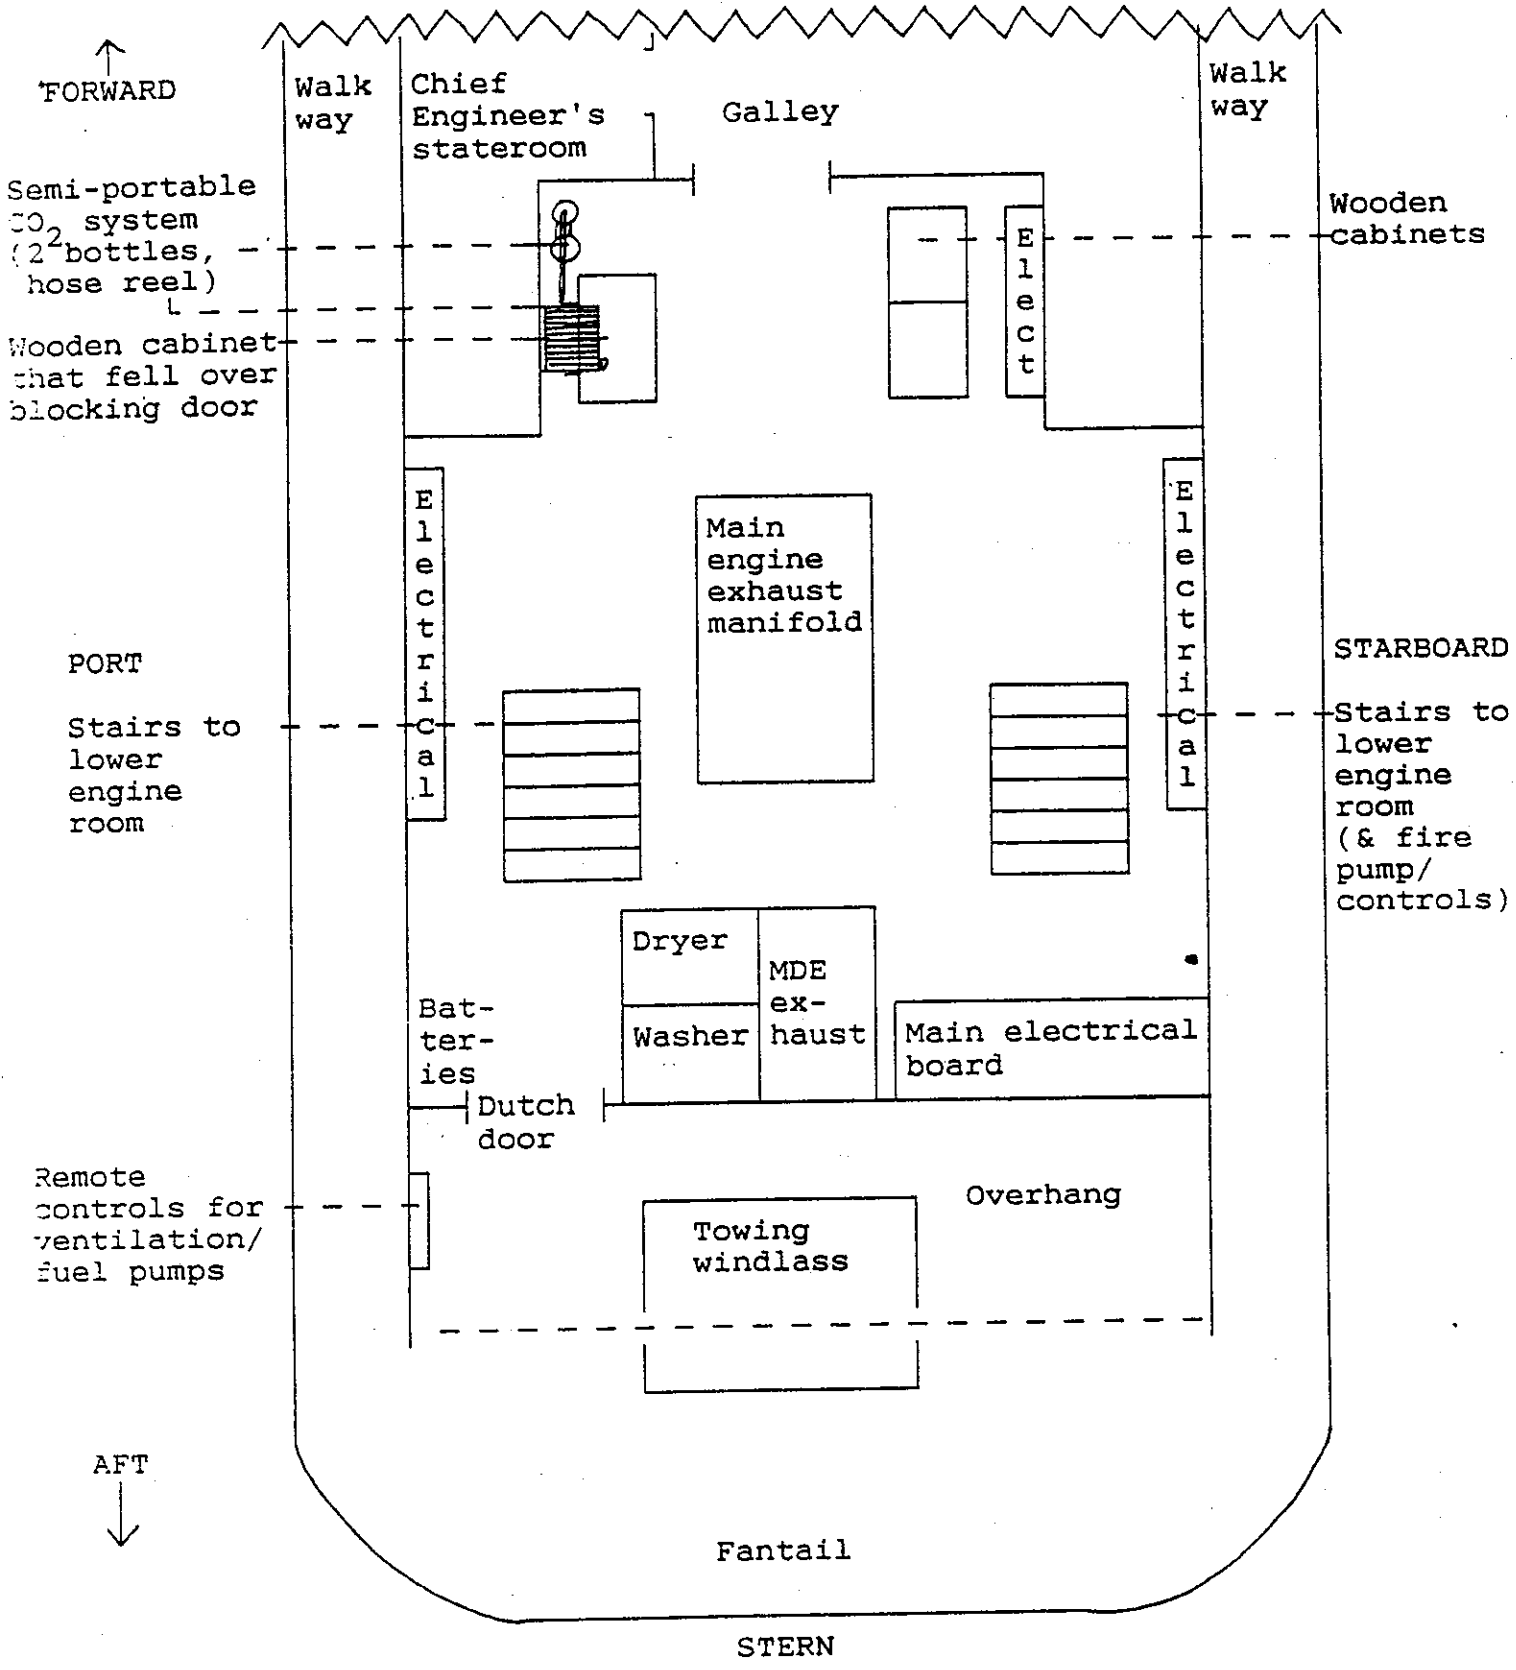
DIAGRAM OF THE UPPER ENGINE ROOM OR "FIDLEY (not to scale)

The fidley space above the lower engine room was approximately 20 feet long (see following page for diagram of this space). The after 12 foot length was approximately 19 feet wide and the forward 8 foot length was 7 feet wide. The overhead was approximately 9 feet above the grating except immediately below

the stack opening. Two watertight dutch doors led to the main deck, one aft and one to port. A third non-watertight door led forward to the mess deck and galley. Flammable 1/4 inch sound proofing fiberboard covered the fidley bulkheads and overhead. Fiberglass insulation filled the 3 inch deep, 18 inch wide spaces between the bulkhead frames behind the fiberboard. Two open metal stairways, one port and one starboard, led down to the lower engine room. Two 16 inch portholes were located, one each in the port and starboard fidley bulkheads. Combustion air to the main engine was through an 18 inch diameter steel pipe descending from the air-intake space aft in the exhaust stack casing through the fidley to the turbo charger in the lower engine room. All other diesel engines used ambient air for combustion air. Ventilation for the engine room and fidley included electric exhaust and supply fans in the stack. Other openings to the fidley included gaps above and below the fidley/mess deck door (through which the smoke was first seen coming out of the fidly) as well as numerous non-tight pipe and electrical runs through this same bulkhead. Four foot square louvered exhaust ventilation ducts were on each side of the stack. Each was fitted with a dogged steel door damper. Ventilation supply steel trunks were located at the outboard aft corners of the stack deck. The air intake louvers installed inboard in these trunks had no closing apparatus. The deck grating and stair openings allowed free flow of air between the lower engine room and the fidley above.

All combustible materials in the fidley (as well as all other compartments on the main deck, stack deck and bridge deck) were completely consumed by the fire. The fidley/mess deck door was off its hinges, laying inside the fidley. Three expended portable fire extinguishers were also on the deck grating just inside the doorway. Spare diesel engine parts that had reportedly been stored in the three wooden cabinets were scattered over the deck grating throughout the fidley, several inches deep in places. All above showed considerable fire damage. The soundproofing fiberboard bulkhead and overhead covering had been completely consumed. Glass globes around light fixtures on the centerline were found melted and deformed. The

13. The presence of combustible, inadequately secured wooden cabinets in the fidley contributed to the crew's difficulty in fighting the fire.
14. Combustible materials used in construction of the vessel contributed fuel to the fire.

23. The master's failure to adhere to the provisions of the vessel's stability letter, specifically allowing the aft fidley dutch door to remain open, likely contributed to the escalation of the fire.
